PROJECT: WISCONSIN RIVER TOTAL MAXIMUM DAILY LOAD SAMPLING

PROJECT: BLUE-GREEN ALGAE TESTING & IDENTIFICATION

CONCLUSION FOR WISCONSIN RIVER PROJECTS 2010

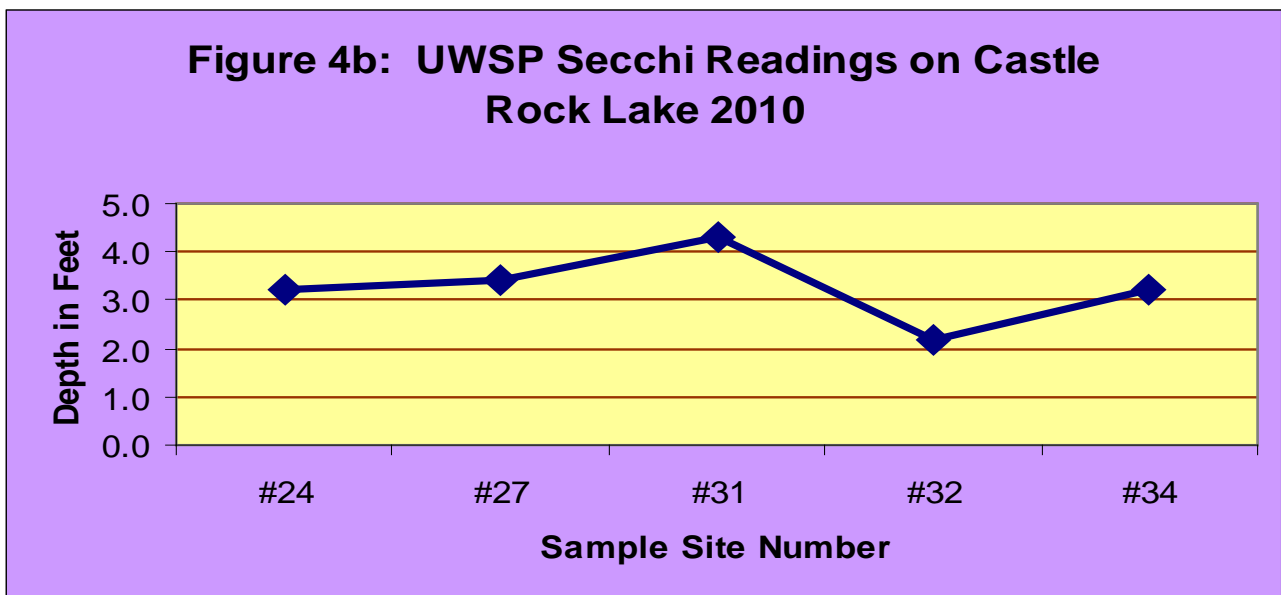
62 samples were taken by students and staff of UW-Stevens Point during 2010, starting in April and concluding in early September. The growing season samples were taken in alternate weeks to those of the volunteers, i.e., the volunteers took a sample, the next week UWSP took a sample, then the volunteers, and so on. These samples were taken at 5 points each on Petenwell & Castle Rock Lakes. Figures 4a and 4b show not only the results for these points from the UWSP sampling, but also the volunteer averages for these sites, and the overall average for that point.

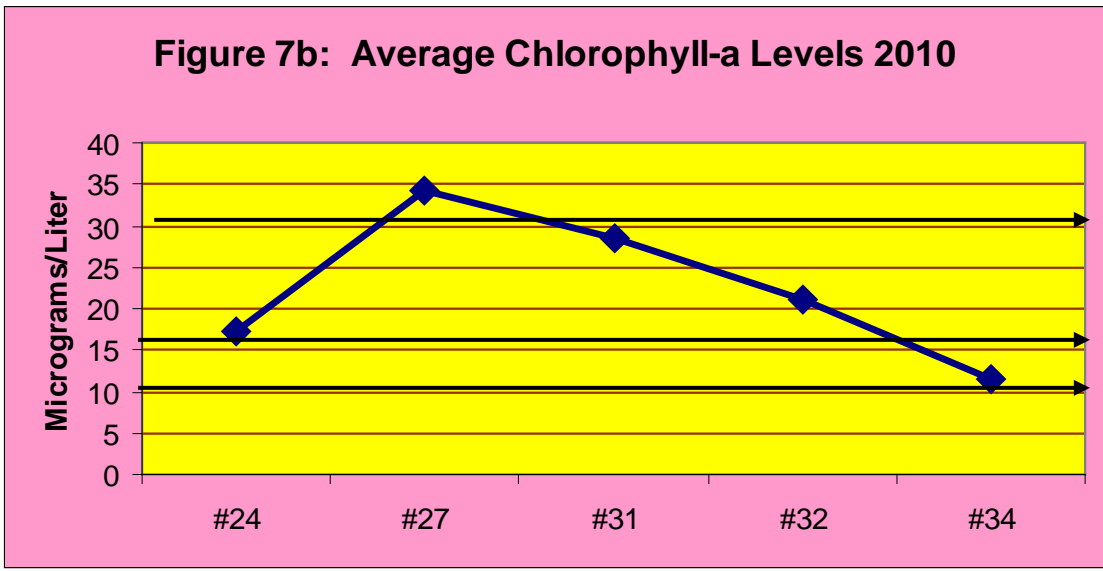
Chlorophyll-a levels in Castle Rock Lake ranged from 11.4 micrograms/liter (near the “V” in Castle Rock Lake) to 34.3 micrograms/liter (in the middle of the lake). Site #34 was in the “fair” category for chlorophyll-a levels; sites #24 and #32 were in the “poor” category; sites #27 and #31 were in the “very poor” category.

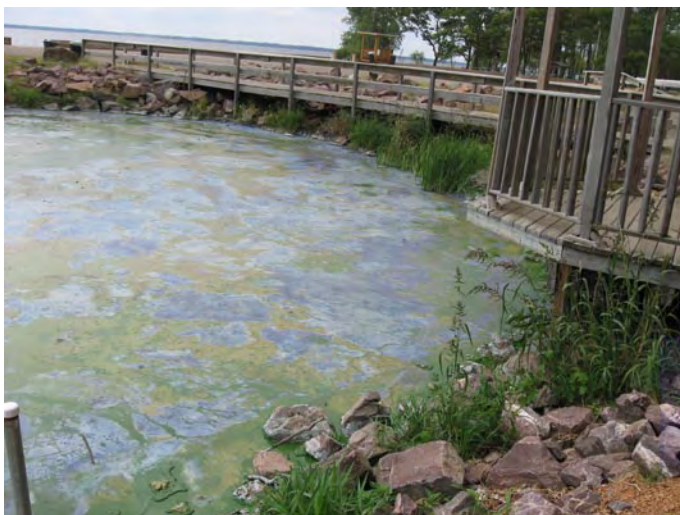
There was also a “blue-green paint-like” substance reported as covering part of the boat basin at Castle Rock Lake Park on the Adams County side. Samples taken of that bloom revealed a significant *Microcystis* bloom. Park personnel then blocked off that part of the boat basin to avoid entry by humans and pets. In August, a sample was taken at the boat basin on the Adams County side of Petenwell Lake located at The Lure restaurant. This, too, showed a significant bloom of *Microcystis*.

Figure 14: Photo of *Microcystis* bloom on at Castle Rock County Park (Adams) 2010
